Name Of Dam: WESTERN BRANCH RESERVOIR
Location: CITY OF SUFFOLK
Inventory Number: VA. 12311

PHASE I INSPECTION REPORT

NATIONAL DAM SAFETY PROGRAM

DEWARD M. MARTIN & ASSOCIATES
WILLIAMSBURG, VIRGINIA
AUGUST, 1979

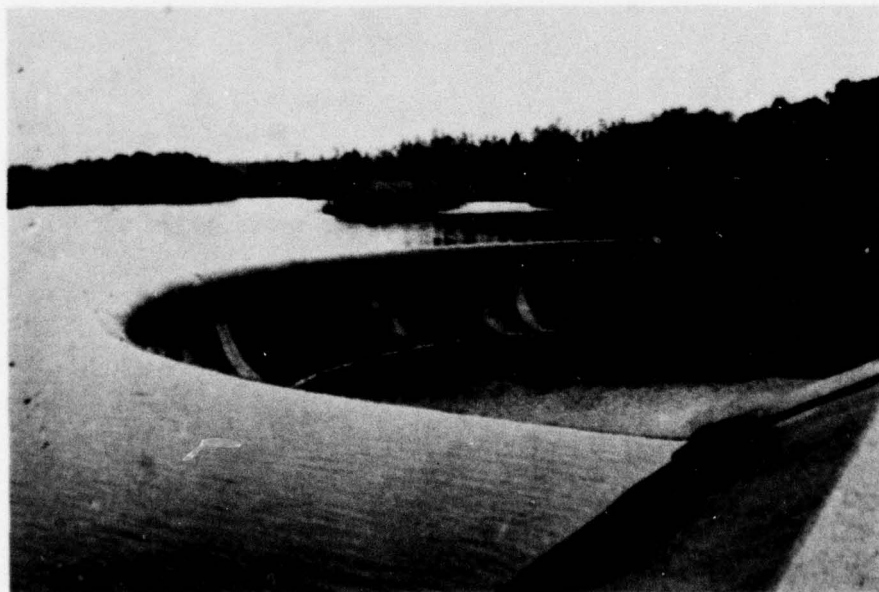
Spillway

3.1.4 Spillway: The concrete spillway shows evidence of surface spalling. Settlement and tilting was observed in a retaining wall panel on the north side of the spillway (see Plate 7, Appendix I). The top of the panel has tilted forward, and the front of the panel's base has settled. Both have moved about two inches.
